Gas broach leads to unique relief well intervention to protect production platform

John Wright, John Wright Company

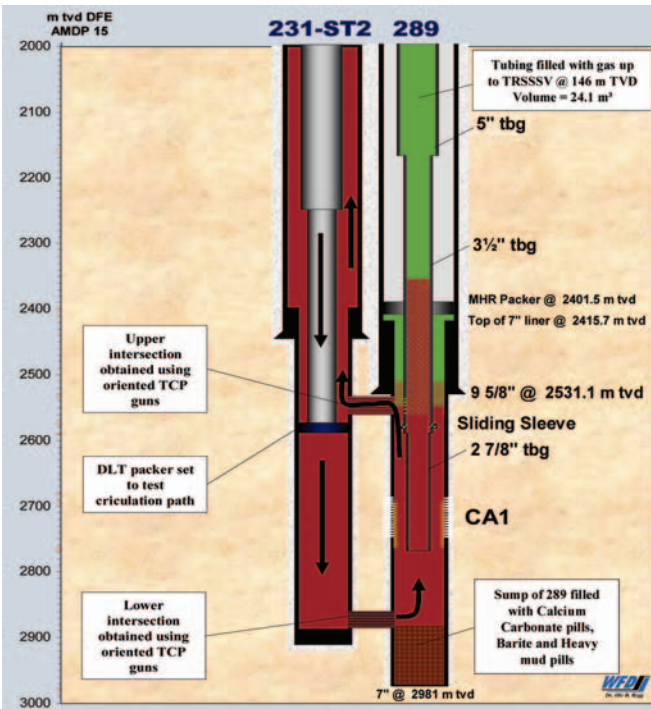
Step 1: Test Hydraulic Communication

Hydraulic communications tests through the perforations were excellent with negligible pressure drop. Once adequate hydraulic communication was confirmed, the upper intersection zone was perforated using the same technique. A re-settable test packer was run to confirm circulation between the lower and upper perforations through the production casing of the problem well.

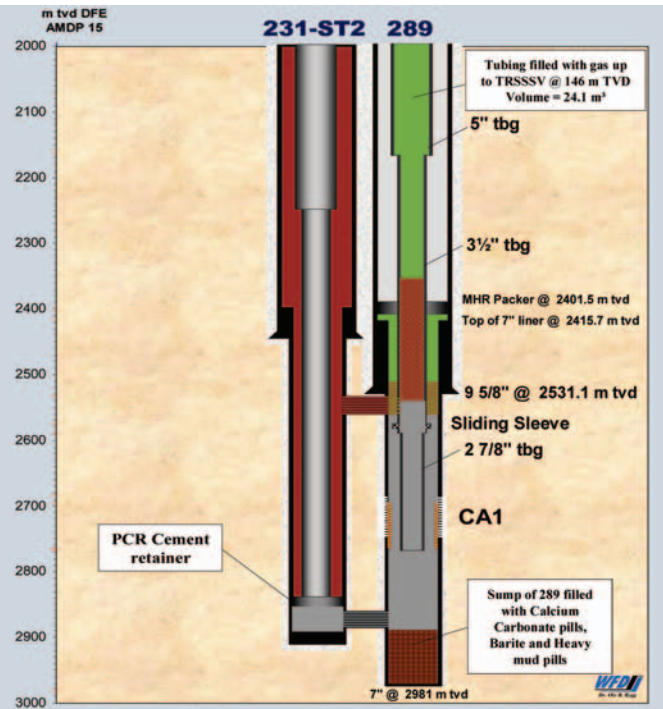
Step 2: Circulate cement into production casing

tion. Cement was circulated down the intervention well's drillstring, through the retainer, up the problem well's production casing and back into the intervention well's annulus. This plugged the problem well's tubing, perforations, and production casing annulus with cement between the lower and upper intersection depths. All diagnostic data indicated the problem well was isolated as designed and the project objectives met.

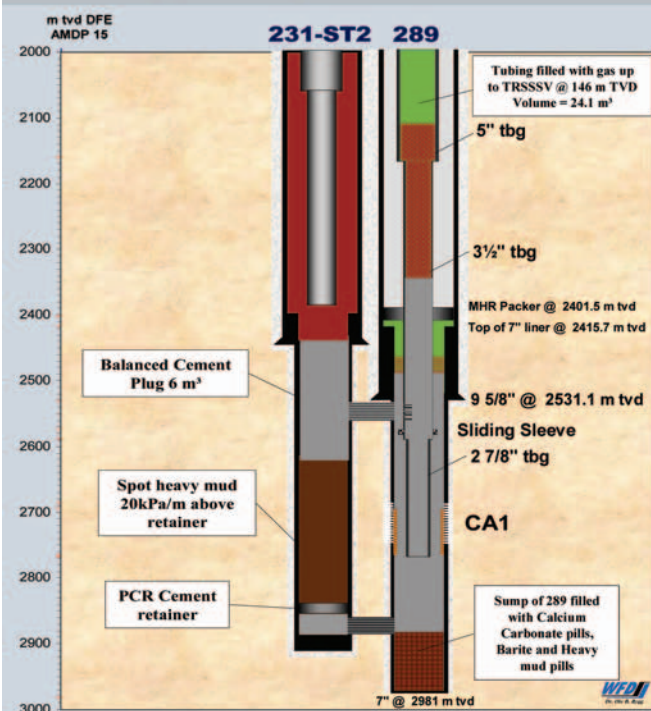
Step 3: Spot balanced plug and squeeze into tubing

As a final assurance, a balanced cement plug was set across the upper perforations and squeezed into the problem well designed to push the top of cement into its tubing above the production packer. With the intervention completed, the intervention well was converted into a producer, replacing the problem well.

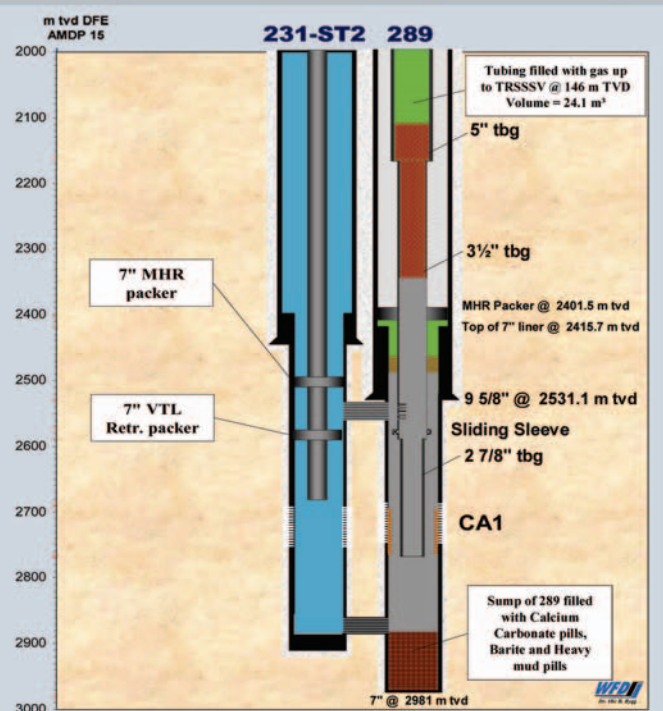
Step 4: Drill out retainer and complete well
